SERVICE AND APPLICATION NOTES

ACC-16-03
March 3, 2016

Equipment Interface Module (10T50) and Outdoor Air Sensor (X2658)

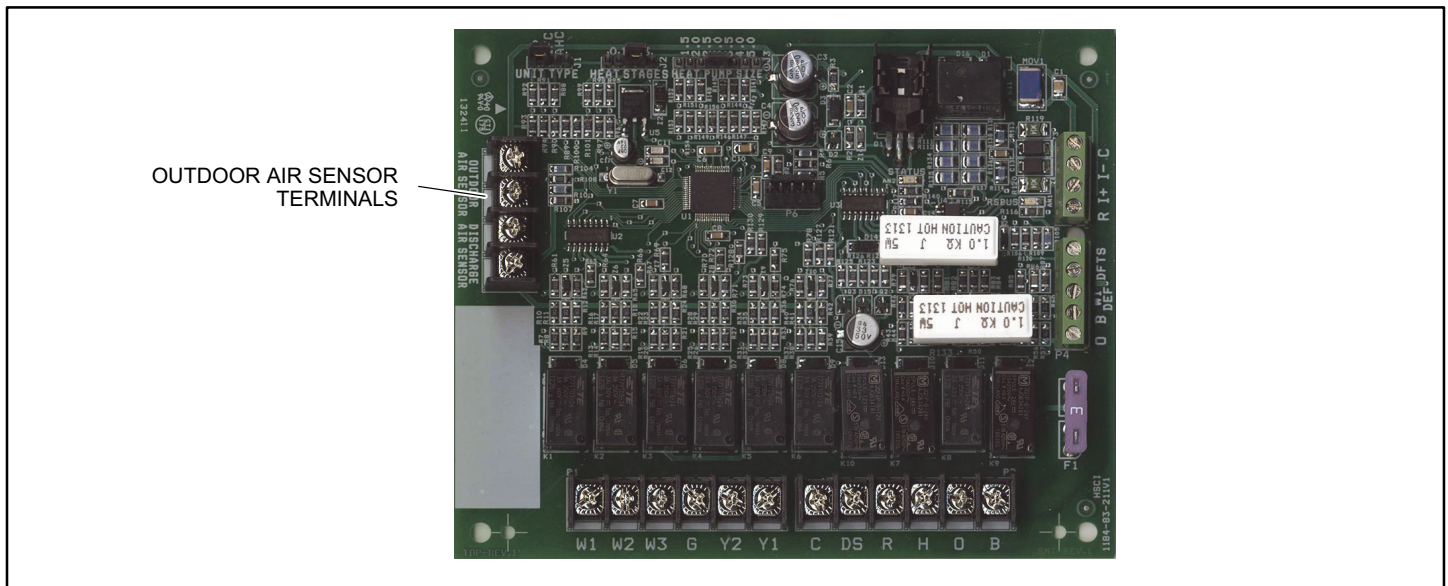
Figure 1. Equipment Interface Module (EIM) Outdoor Air Sensor Terminals

We have had field reports that the Outdoor Air Sensor when used with the Equipment Interface Module may give false temperature readings during times of low outdoor temperatures.

Root cause for issue has been found to be the wrong resistance curve chart used in the EIM software.
