# SERVICE AND APPLICATION NOTES

C-14-02

## Outdoor Control Random Alarm Code 431

### AFFECTED MODELS:

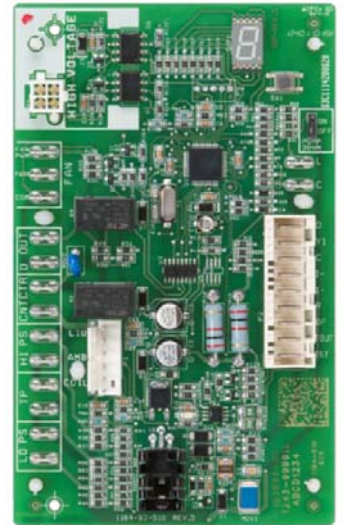
1. The code may randomly occur on the XP25 when the reversing valve is immediately de-energized when the heat pump is coming out of defrost. (Issue occurs in # 98W64 – Part # 103686-01 with software version 1.2 or 1.6).
2. Alarm Code 431 may also occur on the XC25 or XP25 when 24VAC power is **rapidly cycled** to the contactor coil or the 24VAC main power.

1. To prevent the XP25 moderate nuisance alarm code, Lennox engineering has implemented a software change to the outdoor control. A new four second de-energizing delay to the reversing valve was added when coming out of defrost. Order outdoor control 103686-06 (Catalog Number 14G30) which includes this new function.
2. To prevent this moderate nuisance alarm code 431 on both the XP25 and XC25 models, always wait a minimum of 2 to 5 seconds between removing and reapplying 24VAC power to the contactor coil or removing and reapplying 240VAC power to the outdoor unit.
