C-14-08, November 25, 2014

Outdoor Control Alert Code 415 on Dave Lennox Signature® Collection Outdoor Units

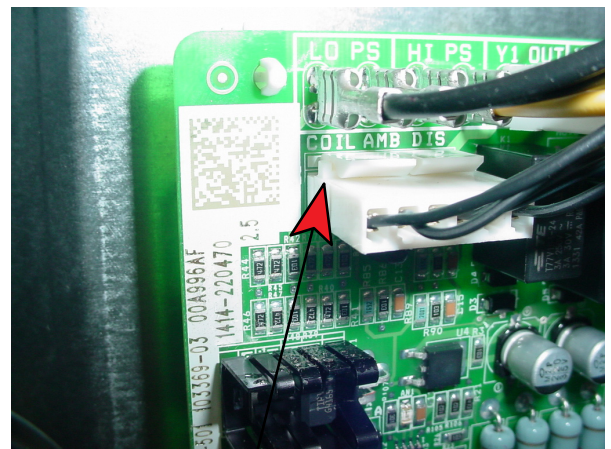
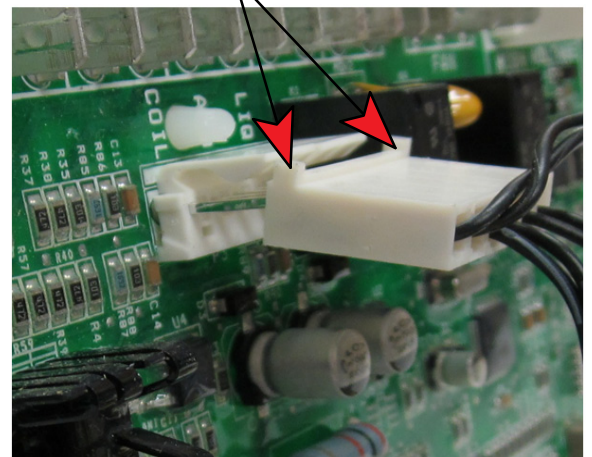
TABS UP

Sensor wire harness plugged in upside down. The result is the discharge sensor and coil sensor are reversed. The two sensors have different resistance value ranges. Because of this, a code 415 will be displayed on the outdoor control and iComfort® room thermostat.

Correct insertion position for tabs is in the up position as exemplified above.

Unplug sensor harness, rotate 180 degrees and plug back in. This will locate the coil and discharge sensors to the proper pin connections on the outdoor control.
