SERVICE AND APPLICATION NOTES

C-15-07
August 10, 2015

Restricted Equalizer Line Issue on Thermostat Expansion Valves (TEV) used with CX35 Coils

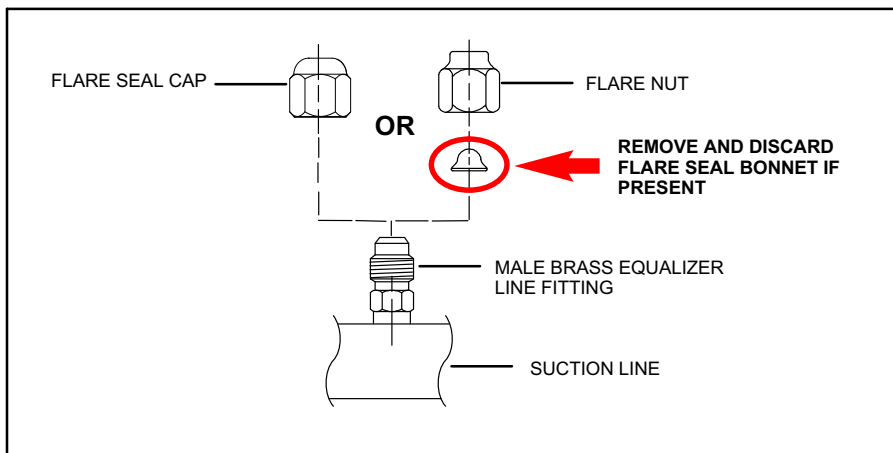
TEV operational issues on systems utilizing CX35 coils due to manufacturer's copper flare seal bonnet blocking the equalizer line. If the equalizer line is restricted (by the presence of the seal bonnet), the pressure sensed at the underside of the diaphragm will no longer correspond to the evaporator outlet pressure and the TEV will not be able to operate as intended.

Copper flare seal bonnet is being left on the male brass equalizer line fitting during manufacturing.

Remove and discard the copper flare seal bonnet if present.
