SERVICE AND APPLICATION NOTES

C-15-05
June 19, 2015

Fin Lubricant Oil Stains Occurring on the Bottom of Air Conditioner and Heat Pump Shipping Cartons

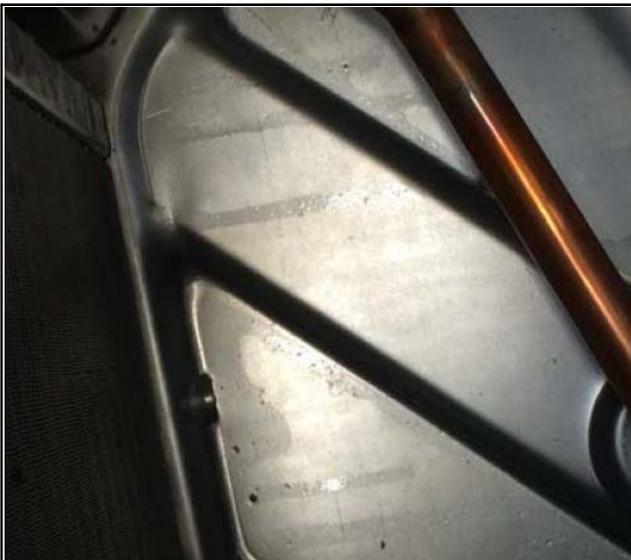
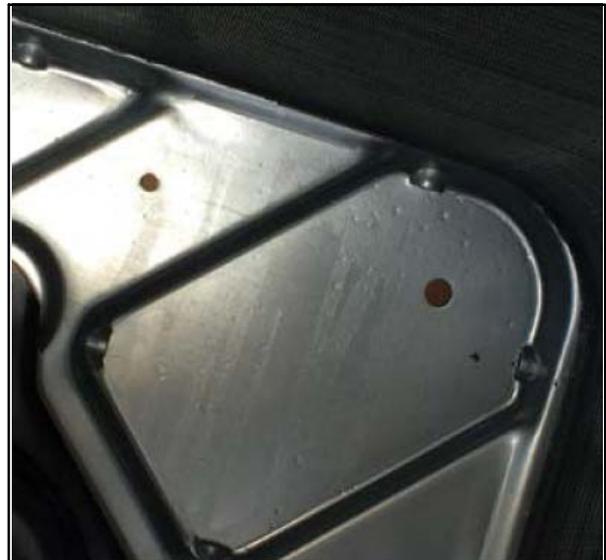
The pictures below illustrate typical fin lubricant draining results. The lubricant is seen around the perimeter of the base pan, and may show streaking toward the center of the pan.

- If the source is fin lubricant, it will be found primarily on the base pan. There will be little or no oil on the shell of the compressor, the motor / fan assembly or the copper plumbing.
- If the oil is the result of a refrigerant leak, it is likely distributed around the inside of the unit. A mist of oil from a refrigerant leak usually coats everything, including the compressor, copper plumbing, fan blades, etc. If the refrigerant leak occurred on the outside of the unit, it is usually visible as an oil stain on the corner posts and in the fin pack or around specific joints.
- Refrigerant oil will capture more soil than fin lubricant will.
- Fin lubricant is soluble in water, so it should easily wash off the affected areas. POE oil repels water and will bead up when exposed to water.
