IAQ-15-01, January 14, 2015

Healthy Climate® Heat Recovery Ventilator (HRV) Drain Pan Cracking during Installation

All HRV3 and HRV5 Models

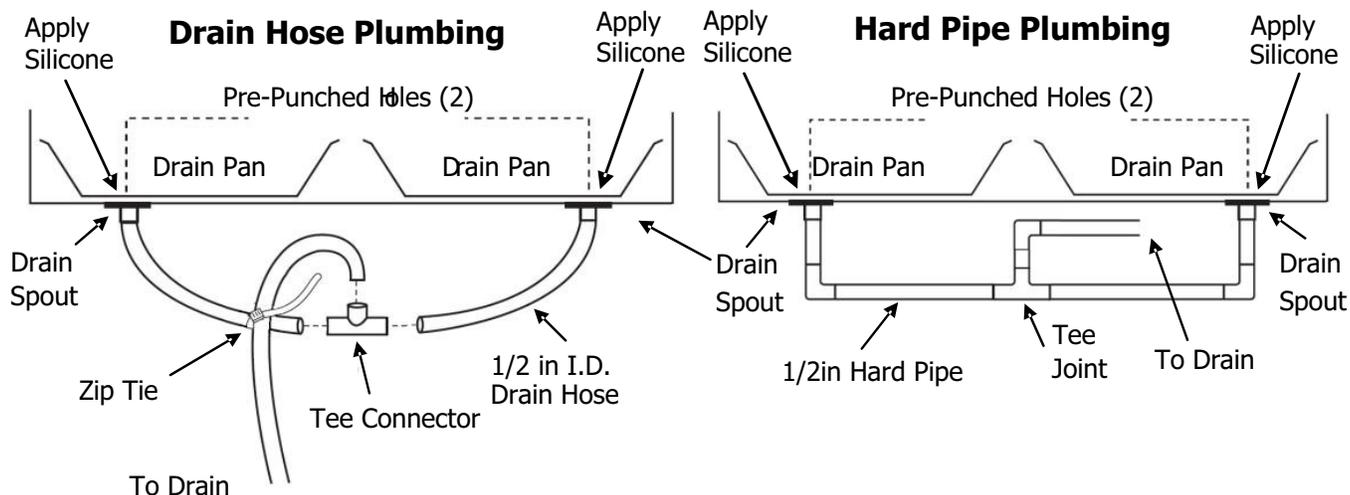
Field over tightening of drain spud is causing cracking of the drain pan.

NOTE: The HRV cabinet has pre-punched holes for the drain (see illustration below).

CAUTION: HAND TIGHTEN ONLY

1. Apply silicone to the base of the drain spout.
2. Insert the drain spout through the hole in the drain pan. Be sure to install the "O-ring" (if supplied) which seals each spout to the pan.
3. Add additional washer to relieve stress from over-tightening.
4. HAND TIGHTEN the washers and lock nut which hold the drain spout in place.
5. Construct a P-trap using the plastic tee connector.
6. Cut two lengths of 1/2 inch drain hose (not included) and connect the other ends to the two drain spouts.
7. Position the tee connector to point upward and connect the drain line.
8. Tape or fasten base to avoid any kinks.
9. Pour a cup of water into the drain pan of the HRV after the drain connection is complete. This creates a water seal which will prevent odors from being drawn up the hose and into the fresh air supply of the HRV.

NOTE: Information concerning adding an additional washer to relieve stress when over-tightening will be added to the installation instruction.
